SUBJECT: Site Inspection, UMETCO, Wilson-Silverbell Mine, M/037/027, San Juan County, Utah

Date of Inspection: July 1, 2004  
Time of Inspection: About 11:10 a.m. to 12:15 p.m.  
Conditions: Mostly clear, 80's  
Participants: Rahe Junge and Frank Barnett, UMETCO; Paul Baker, DOGM

**M/037/027, Wilson-Silverbell Mine, UMETCO**

**Inspection Dated: July 1, 2004 ; Report Dated: August 11, 2004**

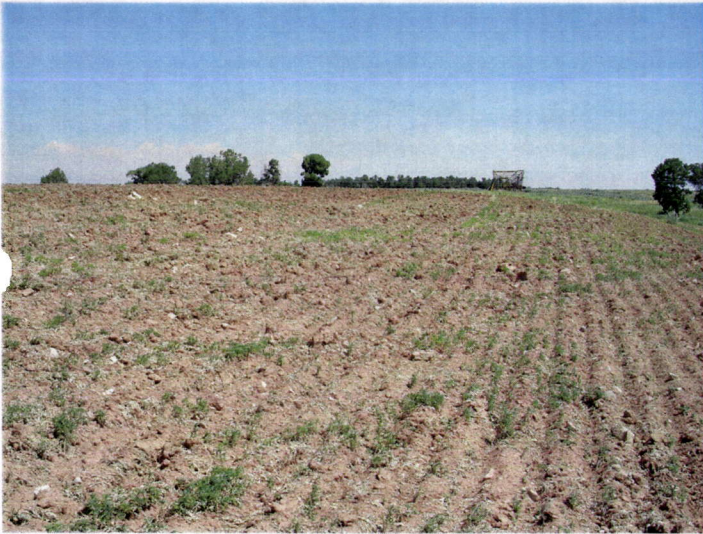
Vegetation on the Wilson site contrasts sharply with the vegetation at Silverbell. There is some perennial vegetation at Wilson, but not much. Most of the vegetation in Photo 1 is weeds. I did not take cover measurements; it seemed pretty clear that the site did not meet vegetation cover requirements.

**Photo 1. The Wilson waste pile.**

There is not enough vegetation on the Wilson waste pile for release. The operator should try seeding this area at least one more time. The slopes are not so steep that it could not be drill seeded, and the operator could also disk the site then immediately broadcast seed. In either case, the operator needs to take steps to ensure the work is done correctly and that this is documented.

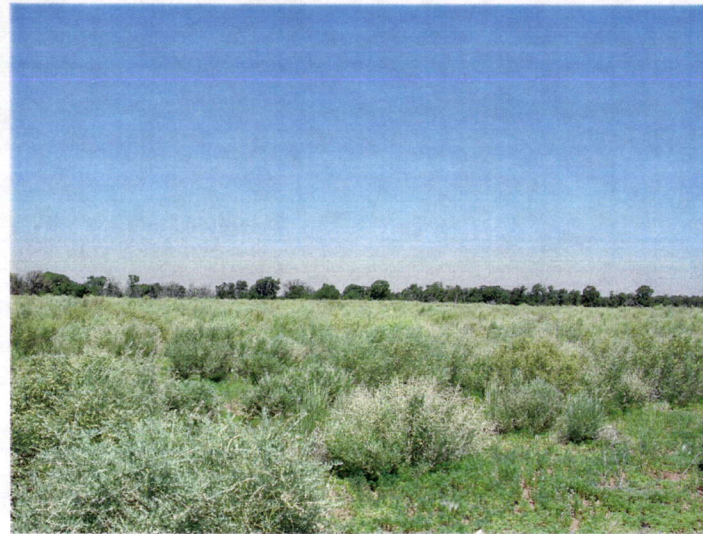
Some of the areas adjoining the Wilson site have good cover (Photo 2—note the unvegetated waste pile in the background), and the ponds area near this pile have a lot of cover from fourwing saltbush (Photo 3).

**Photo 3. The ponds area near the Wilson waste pile. The shrubs are fourwing saltbush.**

Vegetation is adequate in the Silverbell area and in the area of the ponds that these can receive final release. These areas need to be delineated on a map for inclusion in a revised reclamation contract.

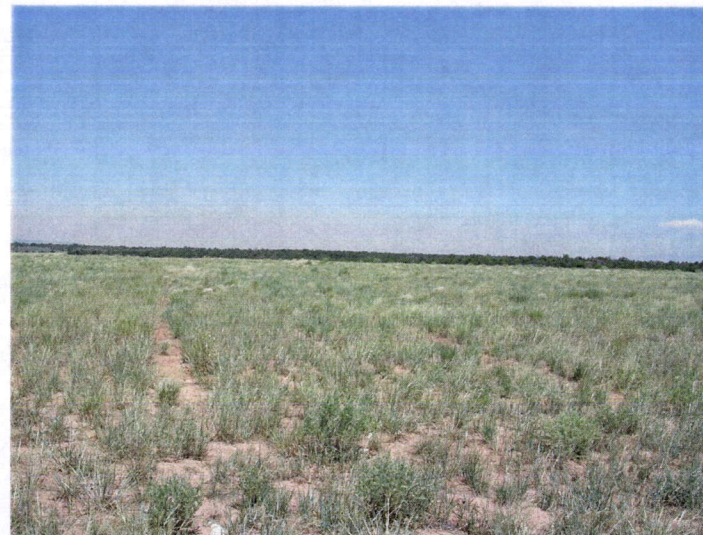
The waste pile at Silverbell was apparently planted at the same time and using the same methods as at Wilson, but the results are much different. Photo 4 is typical of the site although there are a few places (Photo 5) with less cover.

**Photo 4. The Silverbell waste pile. This is typical of vegetation on this pile.**

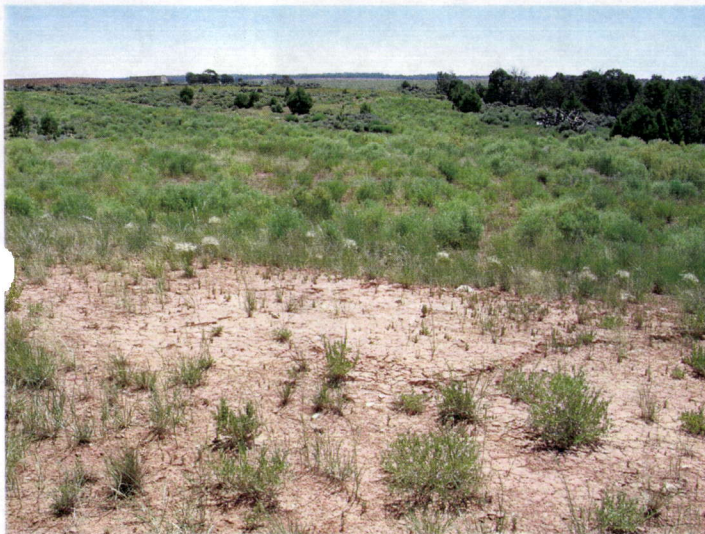
**Photo 5. An area on the south side of the Silverbell pile. There are a few bare areas like this with some minor erosion,.**

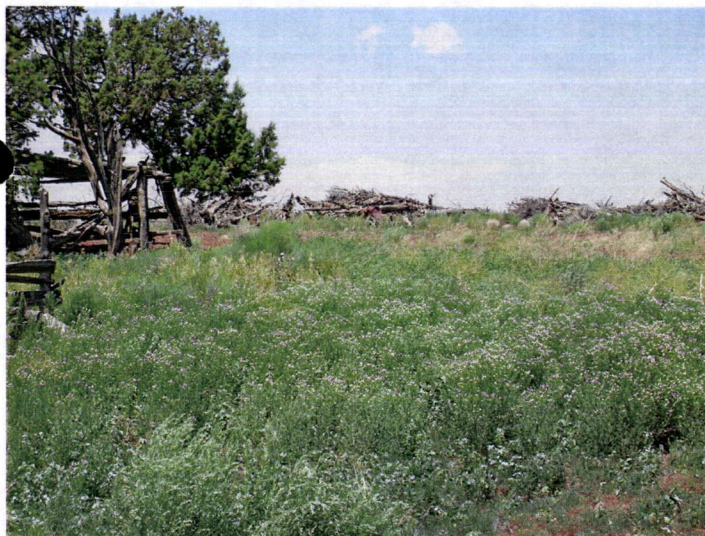
The operator has been working to control Russian knapweed, and while this has been mostly successful, there are still a few patches (Photo 6) within the mine area and on adjacent land.

**Photo 6. Russian knapweed.**

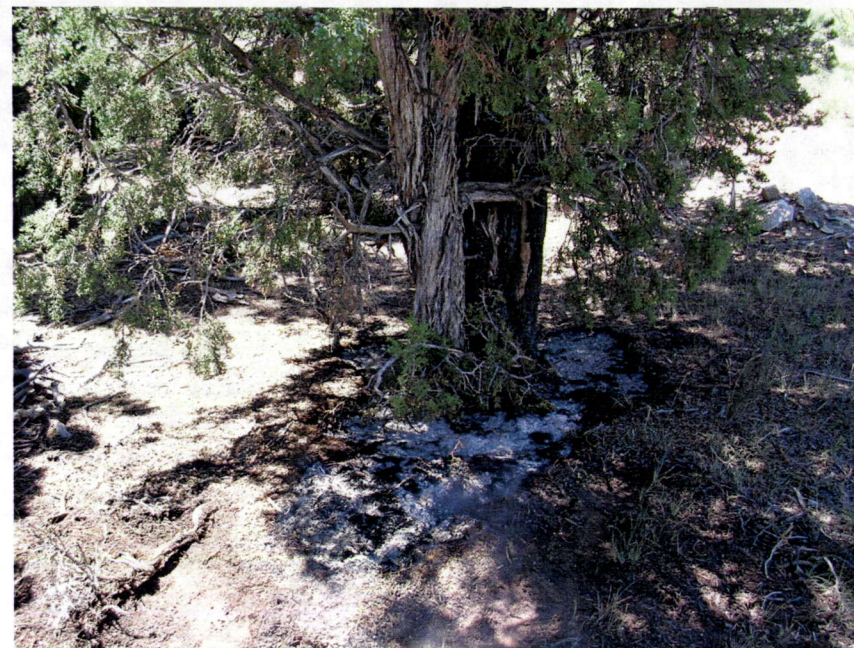
While we were walking around the site, we noticed the smell of smoke and wondered if smoke was drifting in from some of the wildfires to the south and west. We then noticed a nearby juniper (Photo 7) that had been struck by lightning. The organic duff below the tree was smoldering with a little flame occasionally. Mr. Junge and Barnett were going to put it out after I left.

**Photo 7. A juniper that was hit by lightning with some of the burned soil around it.**
